# Manhole Inspection Summary

Manhole # S33K1\_004MH

Insp Date: **3/25/08 9:49 AM**

**Location** Address: **100 Potee St.**

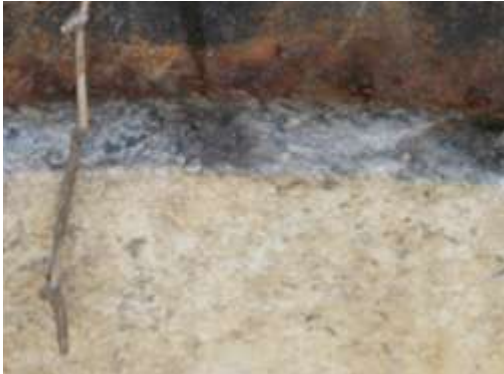
Defect 1

**Frame** Offset: **1** (in.) Condition: ☒ Sound ☐ Cracked ☐ Leaks

Frame Offset

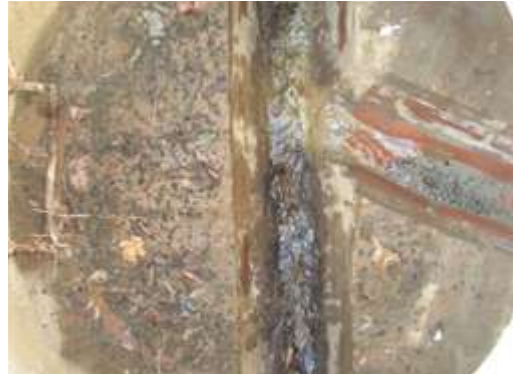
Defect 2

Foreign Objects

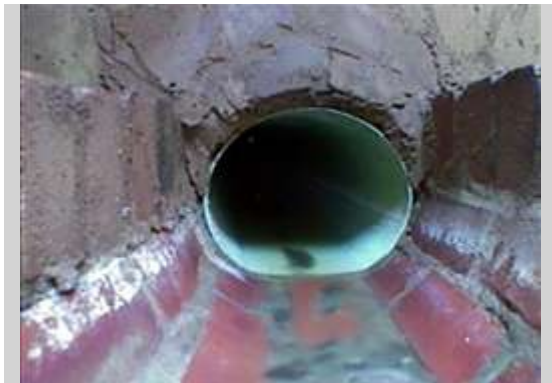
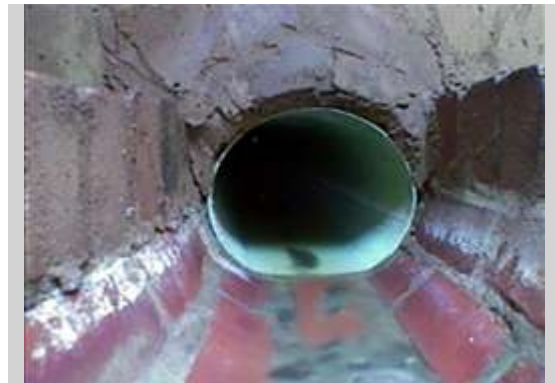
8 in. Circular Gravity Sewer  
Pipe In @ 4 O'Clock

Pipe Height: **8.4** (in.) Rod and Bar (Angled)  
Pipe Material: **PVC** ☐ Pipe Lined  
Invert Depth: **4.58** (ft.) Flow Characteristics: **Slow**  
Deposits: ☒ None ☐ Mud ☐ Sludge ☐ Debris ☐ Grease  
Silt Depth: **1** (in.) Deposits Extent: **Light**  
Infiltration: **None** Pipe Seal Cond: **Sound**

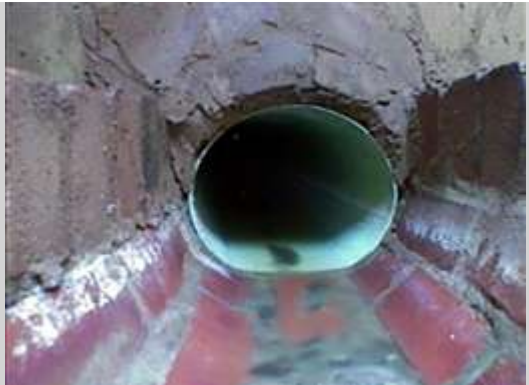
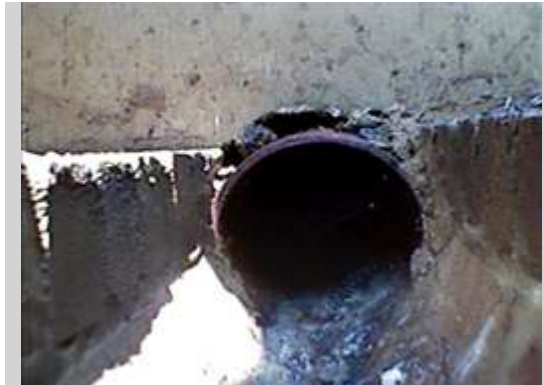
6 in. Circular Service Sewer

Pipe Seal Cond: **Cracked**
